**FRENCH RIVER BASIN  
DUDLEY, MASSACHUSETTS.**

**LARNER POND DAM  
MA 00111**

# **PHASE I INSPECTION REPORT NATIONAL DAM INSPECTION PROGRAM**

**AUGUST, 1978**

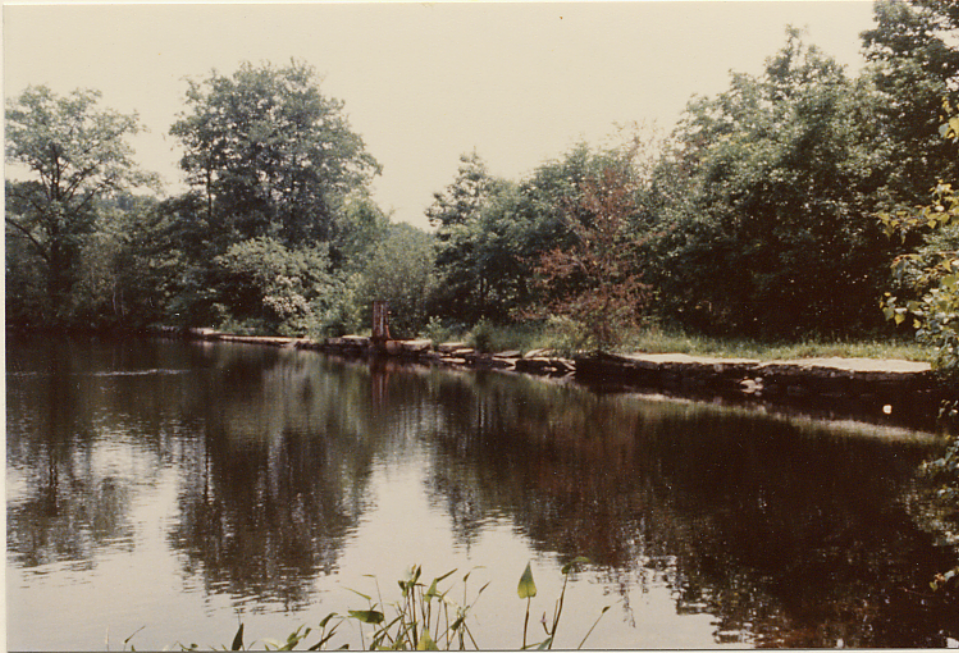
**VIEW OF UPSTREAM FACE OF DAM**

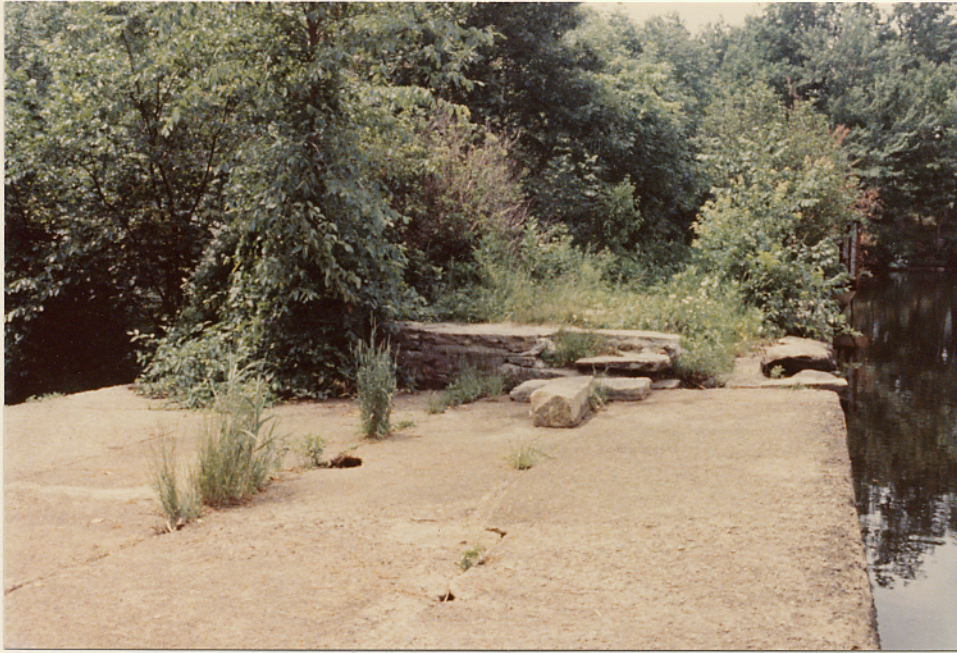
- b. Dam. The main dam is constructed of dry-stone masonry and earthfill. At the time of the inspection the dam crest was overgrown with grass, shrubs and trees to 36 inches in diameter. A footpath was observed along the crest. A 7-foot diameter by 2-foot deep depression was noted on the downstream side of the crest, just east of the outlet conduit. Also, near the inlet structure, some of the embankment has apparently been washed out behind the upstream wall.

NO. 1 - VIEW LOOKING WEST FROM SPILLWAY

- (1) replace the fill along the dam crest after a detailed investigation as to the cause of the large depression in the crest just west of the spillway,
- (2) repair the concrete weir and sidewalls on the spillway,
- (3) remove the brush and large trees from the dam,
- (4) clear all debris and brush from the channel below the spillway, and from the outlet channel,
- (5) institute a program for surveillance and a warning system during periods of unusually heavy rains and/or runoff, and
- (6) implement a systematic program of inspection and maintenance. As a minimum, the inspection program should consist of a monthly inspection of the dam and appurtenances. This should be undertaken in accordance with all applicable State regulations.

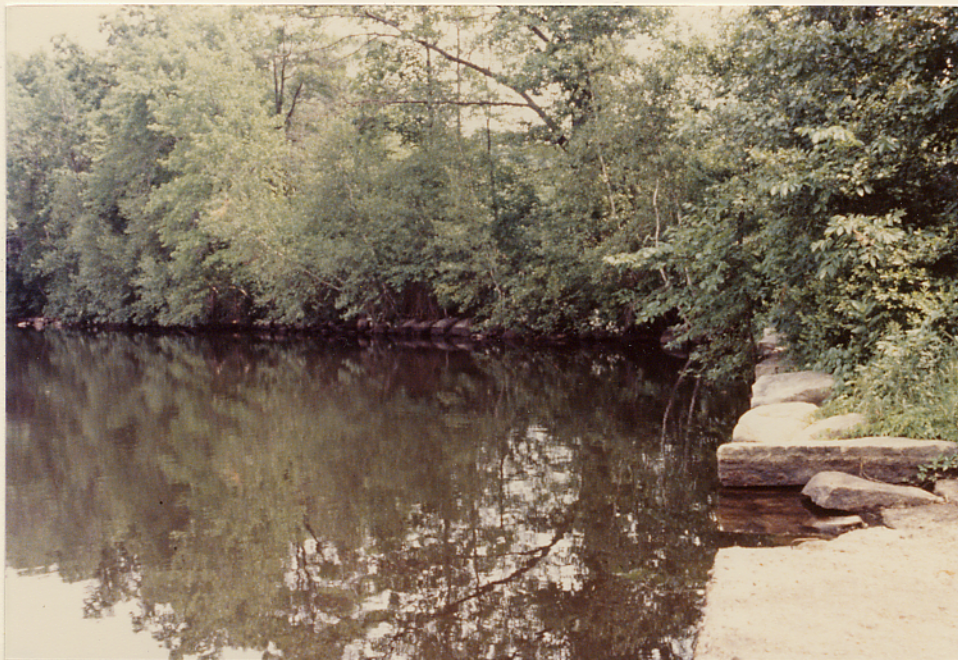
On the eastern side of the spillway, and along the dike, the upstream stone walls are in fair condition, although some capstones are missing on both the dam and dike section. Downstream the vertical wall ends at the dam/dike transition, and the dike face slopes steeply to a swampy area. Near the transition end there is a small amount of seepage from what could be the remains of an additional outlet structure (roughly a 2-foot wide by 1-foot high sluiceway).

NO. 2 - VIEW LOOKING EAST FROM SPILLWAY

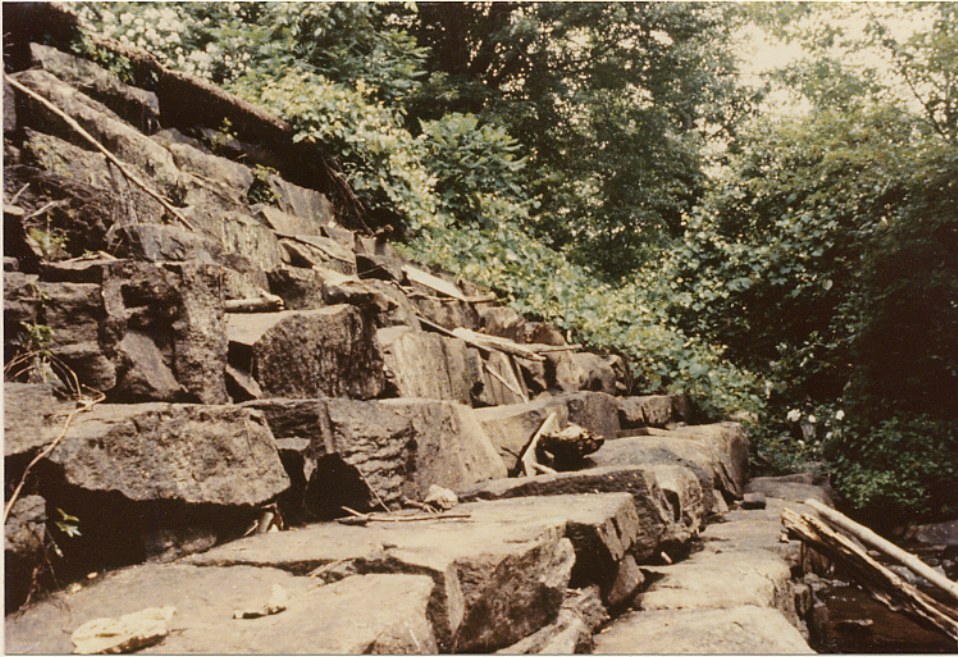
The cascade is in good condition. At the time of the inspection there was no water flowing over the spillway. Water, however, could be heard flowing through the spillway entering the channel below. The stream channel is covered by vegetation.

**NO. 3 - VIEW EAST OF CASCADE SECTION OF SPILLWAY**

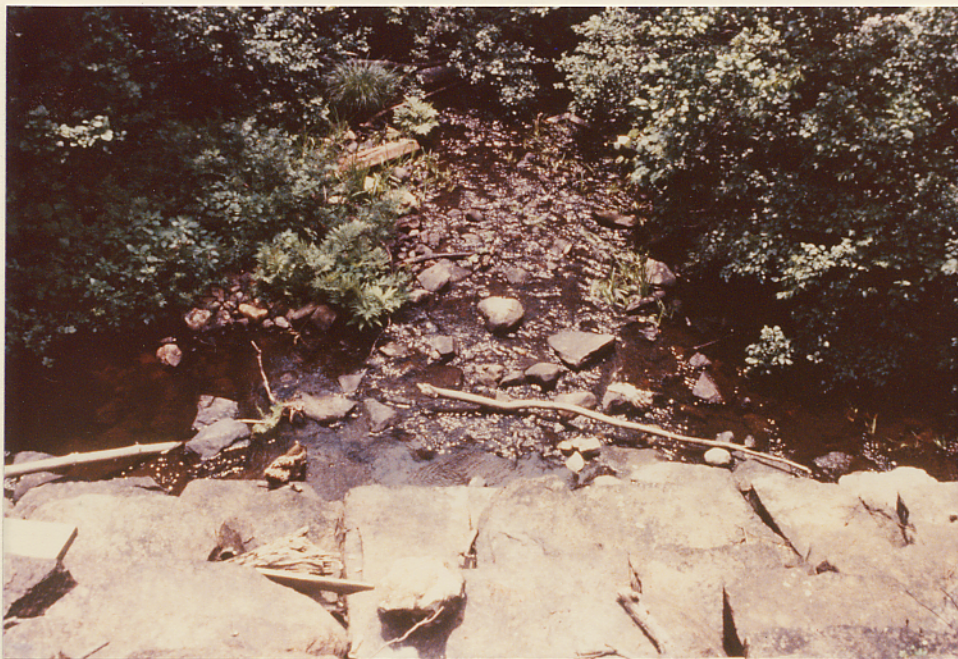
**NO. 4 - VIEW OF DOWNSTREAM CHANNEL  
FROM EDGE OF SPILLWAY**

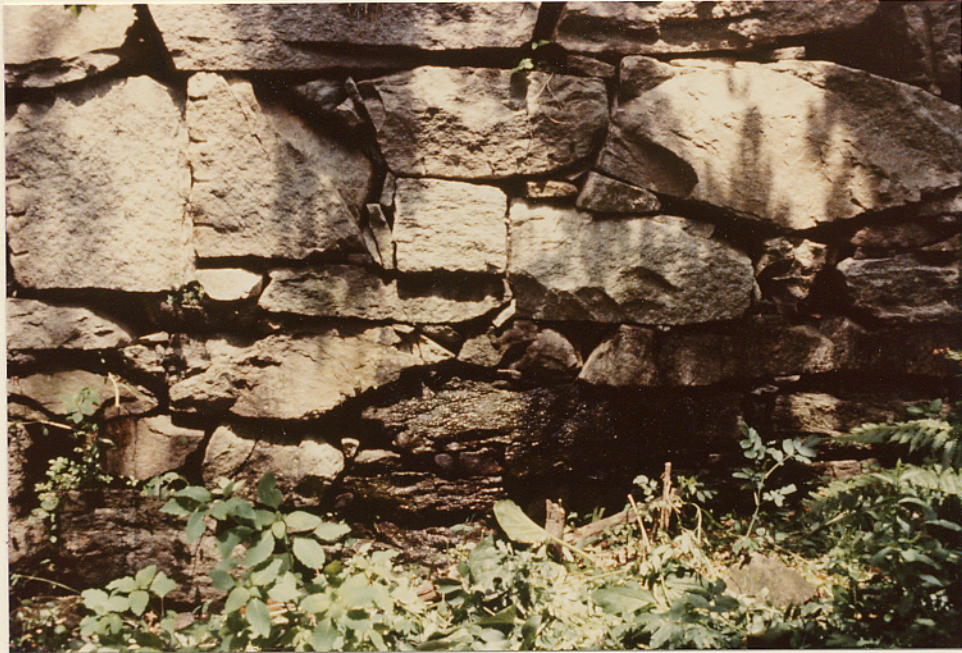
The upstream face of the dam is mostly submerged but appears to be vertical and constructed of stone masonry. The visible upper 1 to 2-foot section shows several capstones missing. The downstream face, also constructed of stone masonry, is vertical and appears relatively sound. Seepage, however, is visible along the downstream wall, from the outlet east to the spillway, extending from 3 to 5 feet high along the wall to the ground. The wall is damp and water was observed at the toe near the spillway.

NO. 5 - VIEW OF DOWNSTREAM DAM FACE 40 FOOT WEST OF SPILLWAY

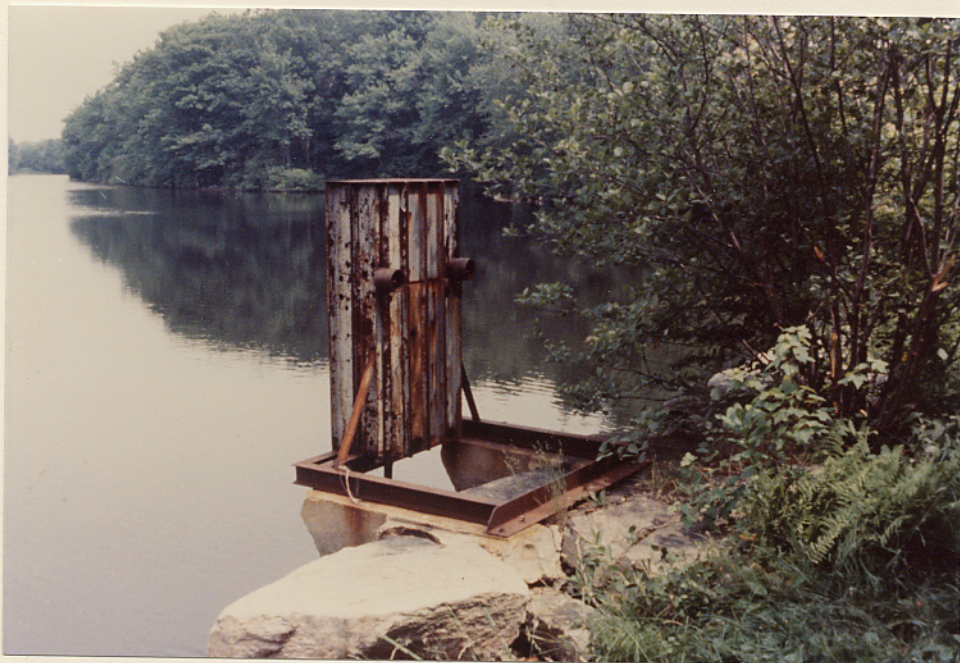
A metal box housing the gate control mechanism is in fair condition. The box was locked but the Owner reports that the gate is in operating condition.

- 4.3 Maintenance of Operating Facilities. The box housing the gate valve was recently repaired, and the Owner states that the screw mechanism was at some time replaced by hydraulic jacks. The leakage around the outlet conduit requires attention.

NO. 6 - VIEW OF CONTROL MECHANISM FOR OUTLET CONDUIT
